## TROUBLESHOOTING GUIDE

All hardware on the ALGO 5 Newborn Hearing Screener may be checked at one time by selecting **F5 - Equipment Check** and then selecting **Run Equipment Check**. Individual components may then be checked using **Run Artifact**, **Run Acoustic** or **Run Impedance**.

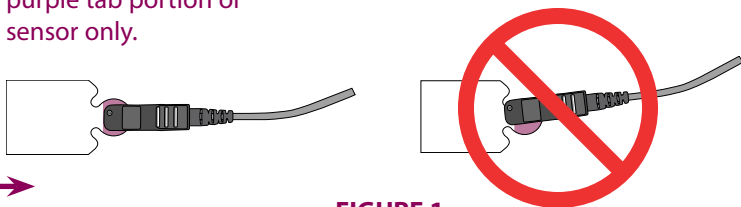
FIGURE 1

**Correct clip attachment:**  
Clip is attached to the purple tab portion of sensor only.

**Incorrect clip attachment:** Clip touches hydrogel portion of sensor.

- Check connections between the tab clips and the sensors (Refer to Figure 1); align the clip so as the wire is closest to the baby's skin. Check the connection between the sensor cable (PCA 5) and the preamplifier (Refer to Figure 2).

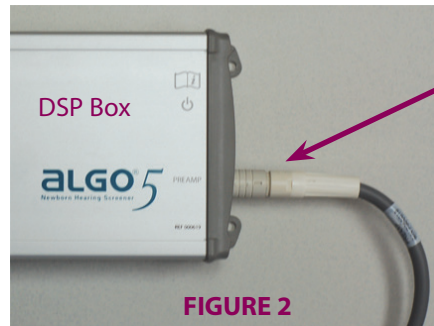
FIGURE 2

**PreAmp to DSP Connection**  
(use the alignment arrows to connect; do not force any connection)

**PreAmp Cable**

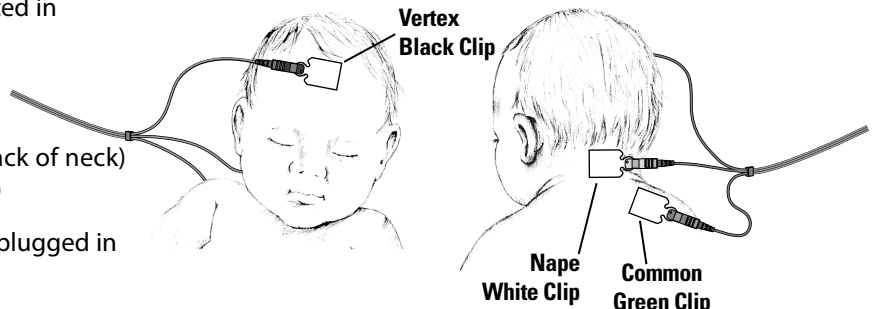
FIGURE 3

- Ensure that the sensors with colored cable clips are correctly placed and firmly attached to the baby's skin with the tab section of all three sensors pointed in the same direction (Refer to Figure 3).

- Black** clip to **Vertex** sensor (center forehead, as high as possible)
- White** clip to **Nape** sensor (center and back of neck)
- Green** clip to **Common** sensor (shoulder)

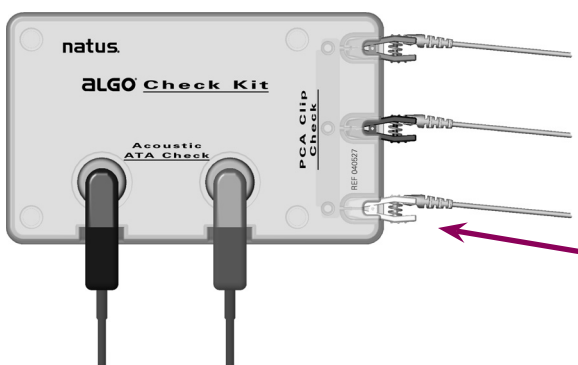
FIGURE 5

You will need the **ALGO Check Kit** (REF 040527) to perform an Impedance Check (Refer to Figure 5).

When attaching the sensor cable (PCA 5) clips to the ALGO Check Kit, make sure the clips are inserted completely into the receptacle.

- If an impedance reading is " $> 99$  kOhms" after careful prepping, select **Equipment Check (press F5 key)** from the Main Window display and perform an **Impedance Check (PCA Clip Check)**. This checks to see if your preamplifier or sensor cable is damaged.

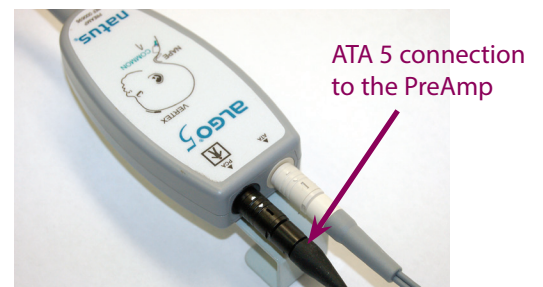
FIGURE 4

**ATA 5 connection to the PreAmp**

- Check that the preamplifier cable is securely plugged in (Refer to Figure 4).

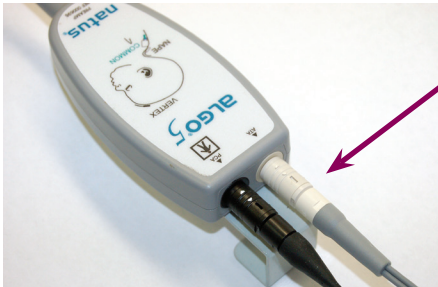
FIGURE 6

Earphone cable (ATA 5) connection to screener

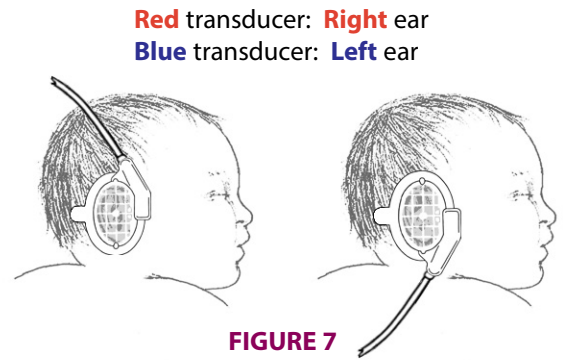
FIGURE 7

Red transducer: Right ear  
Blue transducer: Left ear

- In the case of excessive ambient interference (i.e. room noise) the following events may occur:
  - The screen will slow down or may stop completely.
  - The ambient indicator bar on the Screening display will become more than 90% filled, and the “Check Ambient” message will appear.
- a. Ensure that the earphone cable (ATA 5) is properly attached to the screener (Refer to Figure 6). Also check that the earphone cable transducers are securely attached to the earphones.
- b. Check that the earphones are properly placed and form a good seal around the baby’s ears (Refer to Figure 7). Also check that the earphone cable transducers are securely attached to the earphones.
